## **Explanation and further deduction of conclusions to be drawn from the Alexander L. Kielland Disaster welding engineering evidence.**

From: DR E. J. FRANCE --- M.Weld.I --- FIMMM --- C.Eng.

Date : 31st March 2023

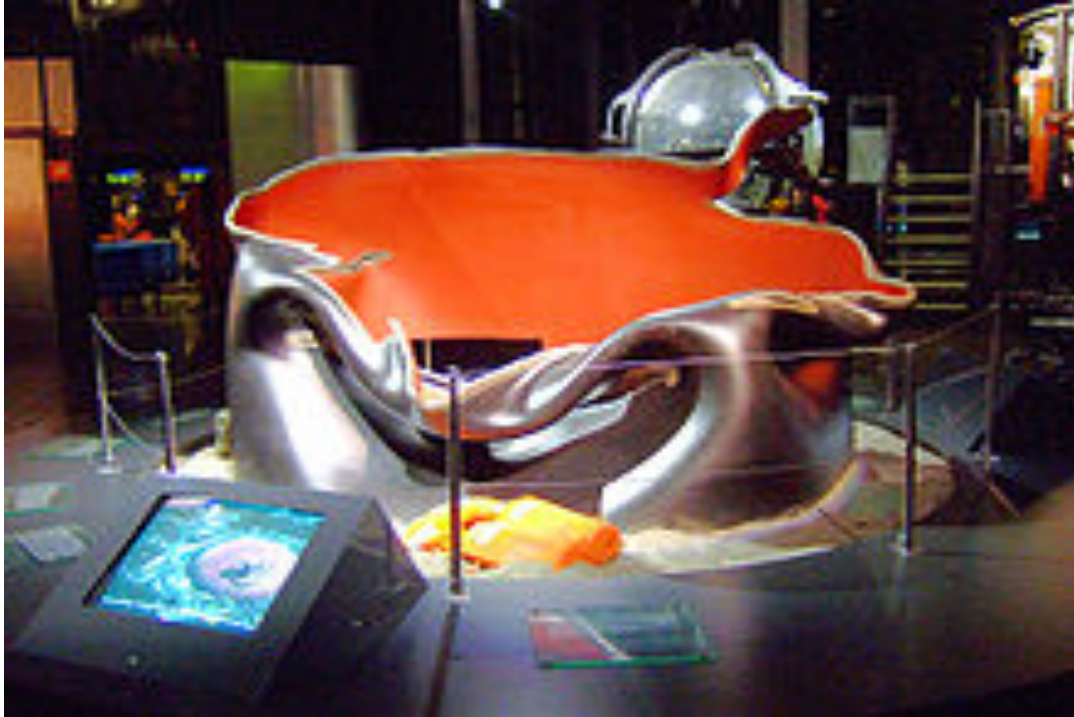
**Figure 1** : How a tubular product form would look if it had been overloaded derived from incorrect stress design calculations and or operational abuse.

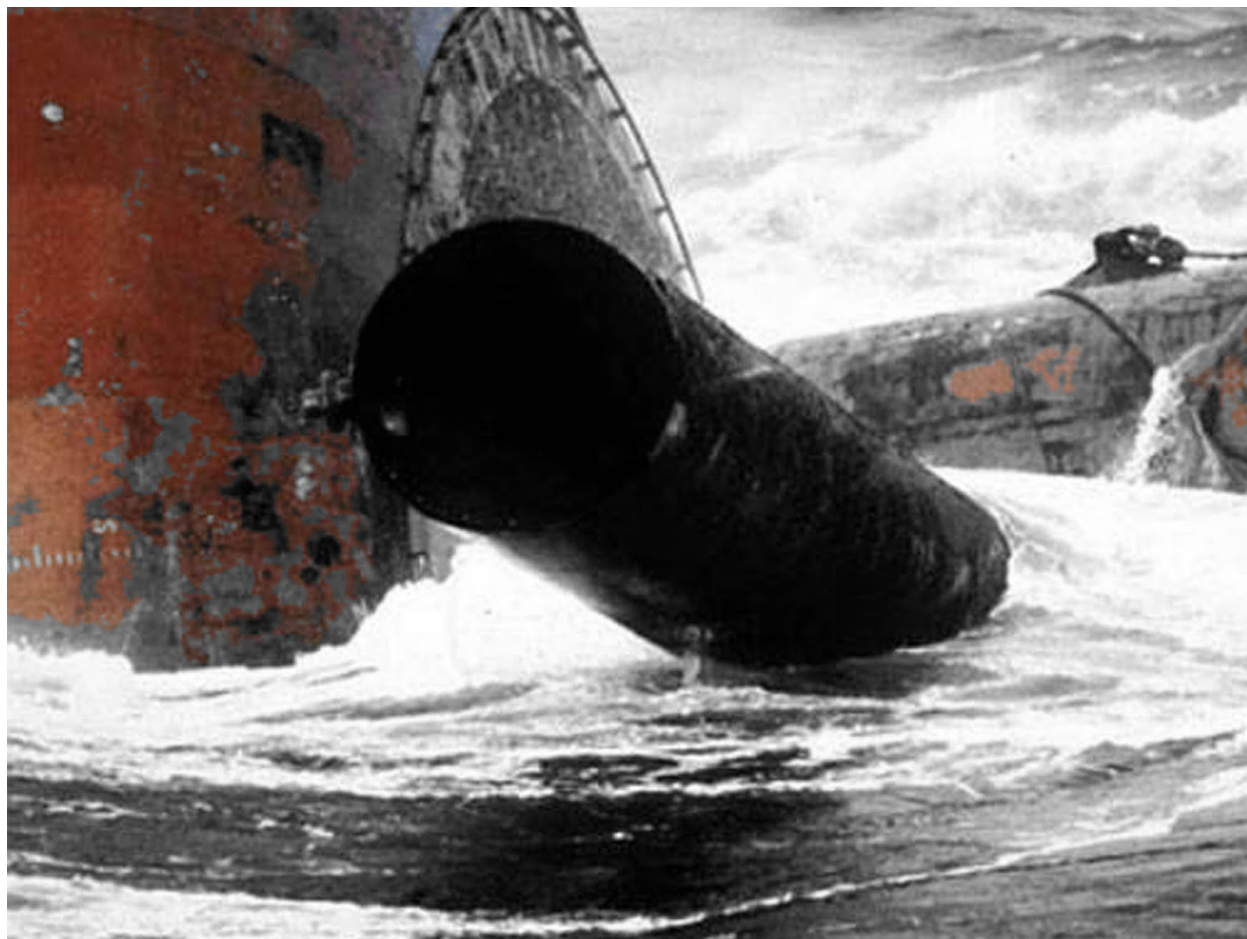
the evidence would be overload with associated strain, i.e. severe plastic distortion effect on product forms, see Figure 1 which illustrates this. **Evidence of this nature was not observed on the platform structure** --- see Fig. 2 and 3. --- If the design stress calculations were inadequate then the platform would not have survived welded fabrication in the shipyard facility nor when it was first launched down the slipway into the sea in the docks. The stresses on all aspects of the fabrication would have exceeded the Yield Point of the steel of construction in all the product forms and welds that constituted the platform. The platform in this situation would have failed by plastic collapse but in one piece , ( not in bits at a time ) i.e. by severe and permanent distortion of the platform, in other words it would not be capable of withstanding service loads in any way. To repeat --- No plastic deformation that would be evidence of indicating the yield point had been exceeded in the main product forms, could be observed in the collapsed remains of the platform, see again Fig. 2 and 3. To further confirm that this “overload conjecture” is simply not true, is the fact that the platform was towed to position in the North Sea and it functioned for four years before failure whilst possessing a crack in the hydrophone weldment. One can draw the fact, with certainty, that the stress calculations were satisfactory and must have complied with the design fabrication specification.

**Figure 2** : No evidence of plastic deformation in the product forms e.g. the brace D6, view the back ground of image at the column D and the float chamber, that constituted the platform overall structure, therefore no evidence of overload.

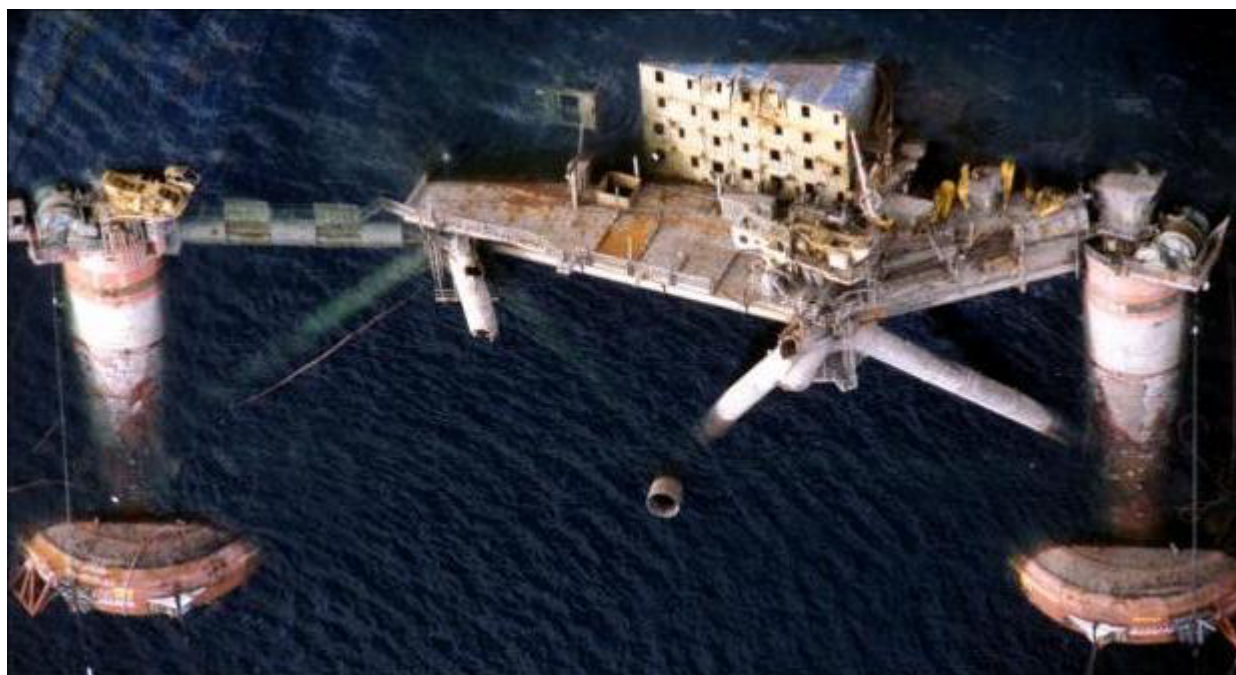
**Figure 3 :** Overall view of the collapsed platform/rig showing no evidence of plastic deformation in the component parts, therefore no evidence for abuse that would cause overload and collapse.

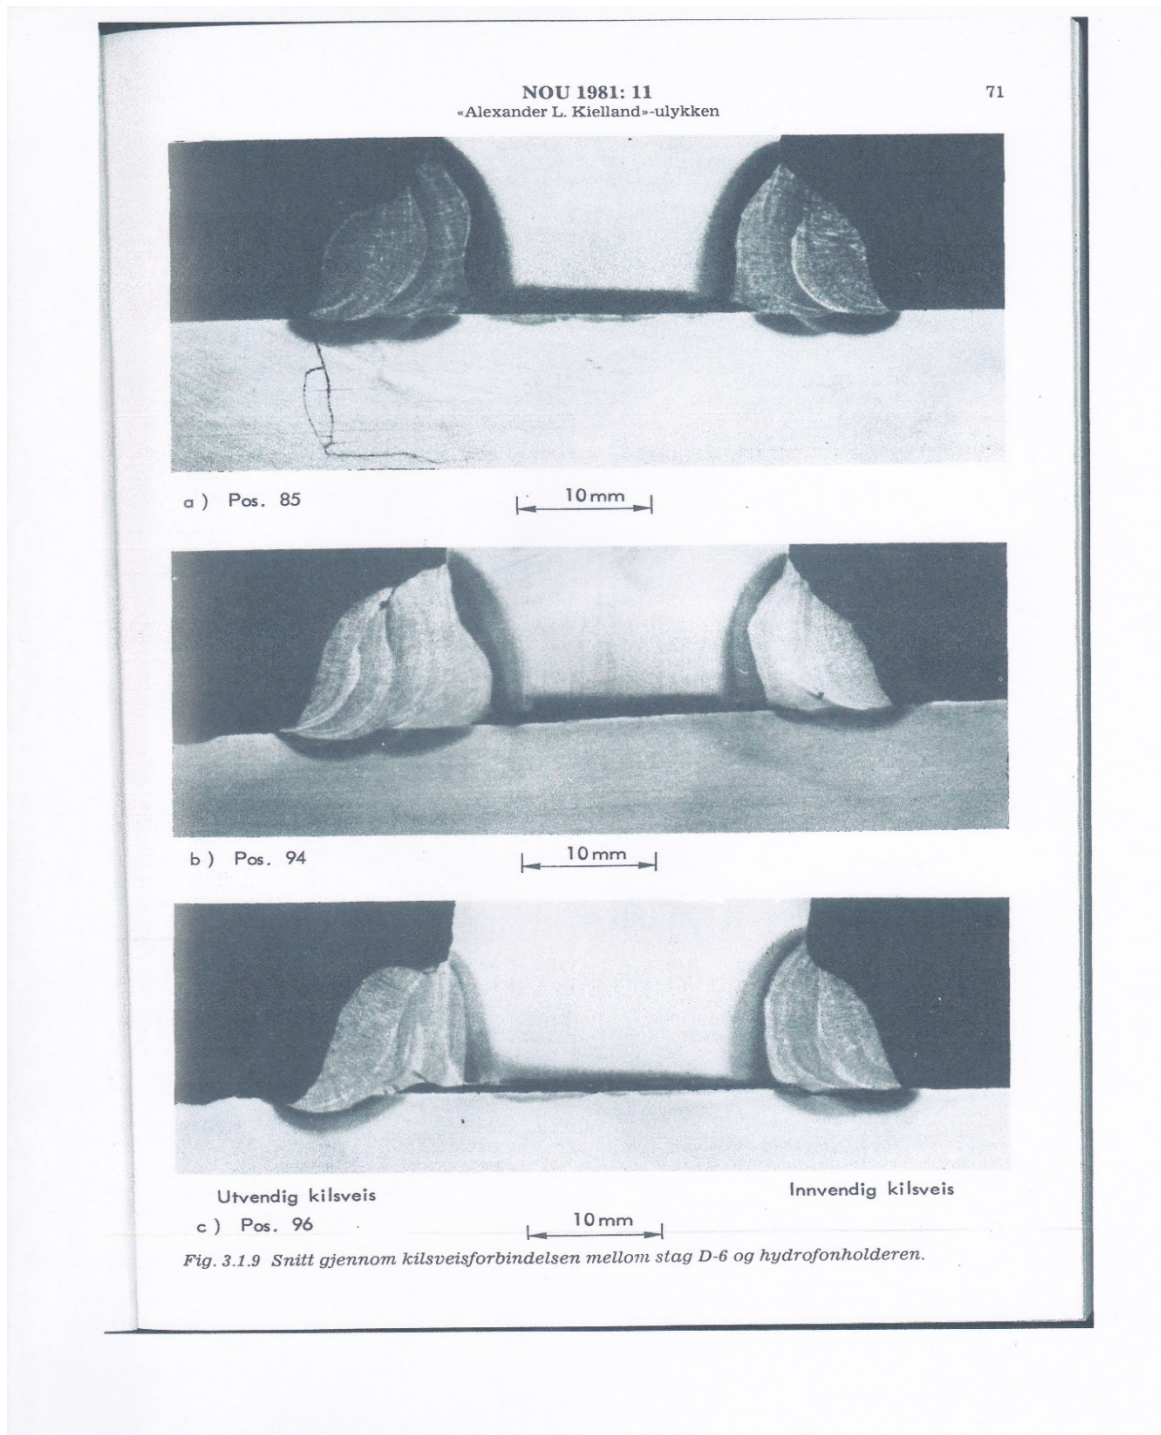
Fatigue cracking relies upon a suitable defect to be in existence prior to the mechanism coming into existence and operation. Welds produced without reference to a qualified weld procedure are a source of incorporated defects that could become mobile. This was the situation in the hydrophone weld which was riddled with hydrogen induced cracks and poor fusion characteristics in the 'as welded condition' on the Alexander L. Kielland platform, whilst in the fabrication shop of the " FRENCH SHIPYARD ". **What is the factual evidence that confirms this comment ? : " the original investigation team, to their credit, found paint on the fatigue fracture surface ". There is only one possible way this could occur and it is that the " hydrophone insert joint " was cracked "as welded" and not inspected, when manufactured in the shipyard fabrication shop, then the joint was painted which would allow ingress of liquid paint into the welded joint, via the hydrogen induced cracks and or lack of fusion characteristics. Evidence of hydrogen induced cracking and lack of fusion defects were shown in the original investigation report, see reference 1 and Figure 4.**

**Figure 4** : Macrosections taken from the remaining hydrophone welded joint showing presence of the hydrogen induced cracks and lack of fusion characteristics where liquid paint could ingress into the steel bulk.

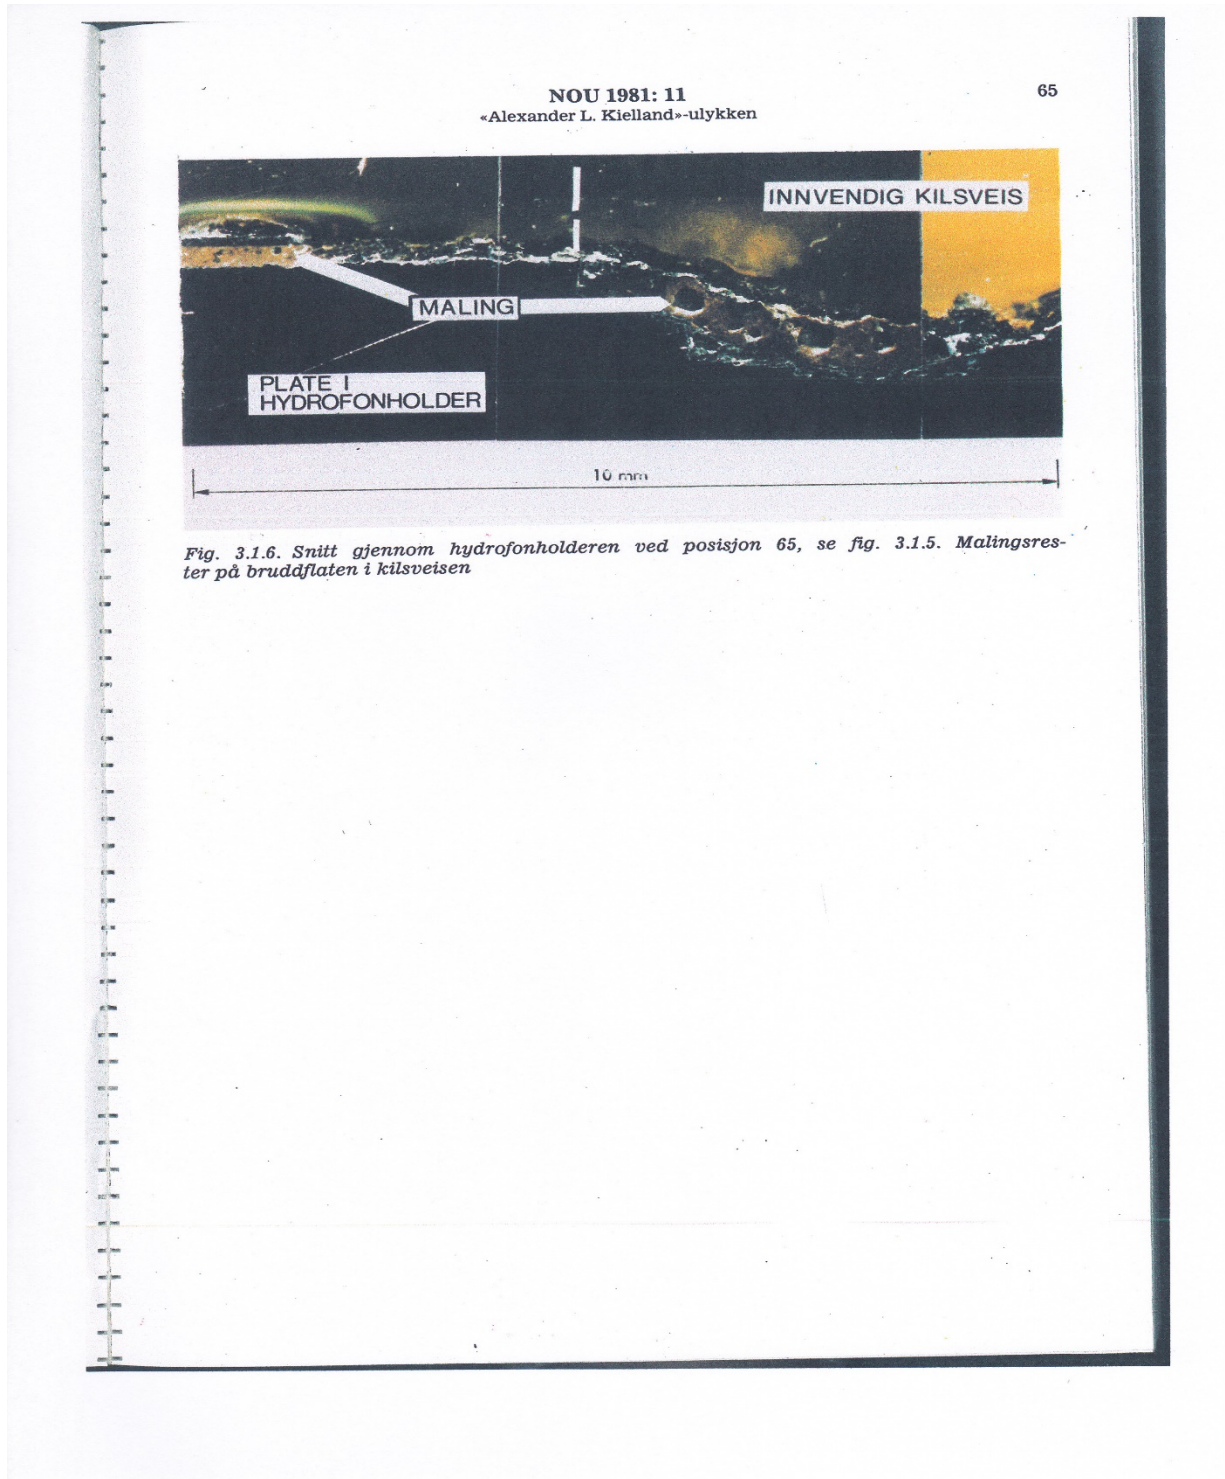
**Answer :-** The significance of the fact that paint was found on the fatigue fracture surfaces, see Figure 5, was lost on the original investigation team as there was no experienced welding engineer present, see reference 1 in the Abstract of the Alexander L. Kielland Disaster paper written by myself --- DR E. J. FRANCE. The consequence was that the true cause of the platform collapse was not and could not be revealed by the original investigation, only the mechanism of failure was highlighted. **( It should be stated here that the original investigation, did identify some salient features of the failure for which they should be given credit, however, it did lack some appropriate people from other relevant scientific disciplines, in order to successfully analyse data and determine the true cause of the failure.)** The paint could only have got onto the fracture surfaces if there were cracks in the fillet weld upon initial fabrication in the shipyard fabrication shop. The presence of paint in these features of the fillet weld, proved beyond doubt that the hydrophone fillet weld was already cracked before the platform first went down the slipway in the shipyard and when the platform first entered service in the North Sea. From these crack origins in the hydrophone fillet weld, see Figure 6, the fatigue crack and or cracks, then, were propagated by cyclic loading powered from wave motion effects. These cracks propagated around the brace leading to its total fracture. Following on from this event the platform became unstable and went into collapse mode. **The reason paint was on the fracture surfaces of the hydrophone insert welded joint was because the weld was not inspected after welding, the shipyard just painted over the weld such that liquid paint would therefore ingress into the weld deposit via these hydrogen generated cracks and areas of lack of fusion, the shipyard workers were therefore obviously unaware cracks were present. The hydrophone insert weld and platform went to sea in this condition. Further, the significance of**

**Figure 5** : Section showing the ingress and presence of paint (maling in Norwegian) on the fatigue fracture surface. (Evidence taken from the original commission report).

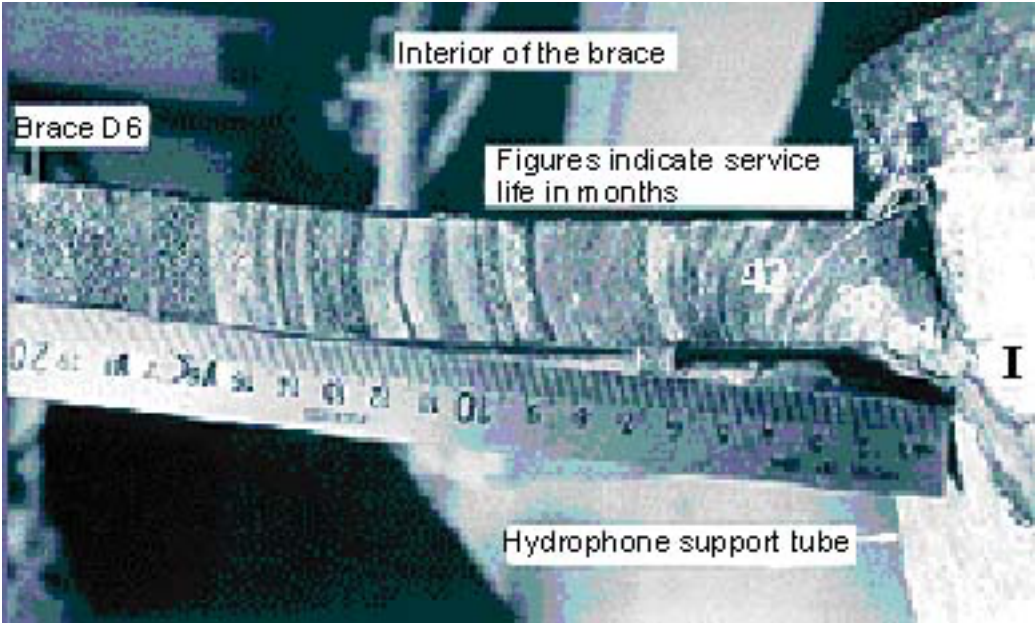
**Figure 6** : Ridge markings on the brace steel wall showing the progress of the fatigue crack away from its origin which was the hydrophone welded joint.

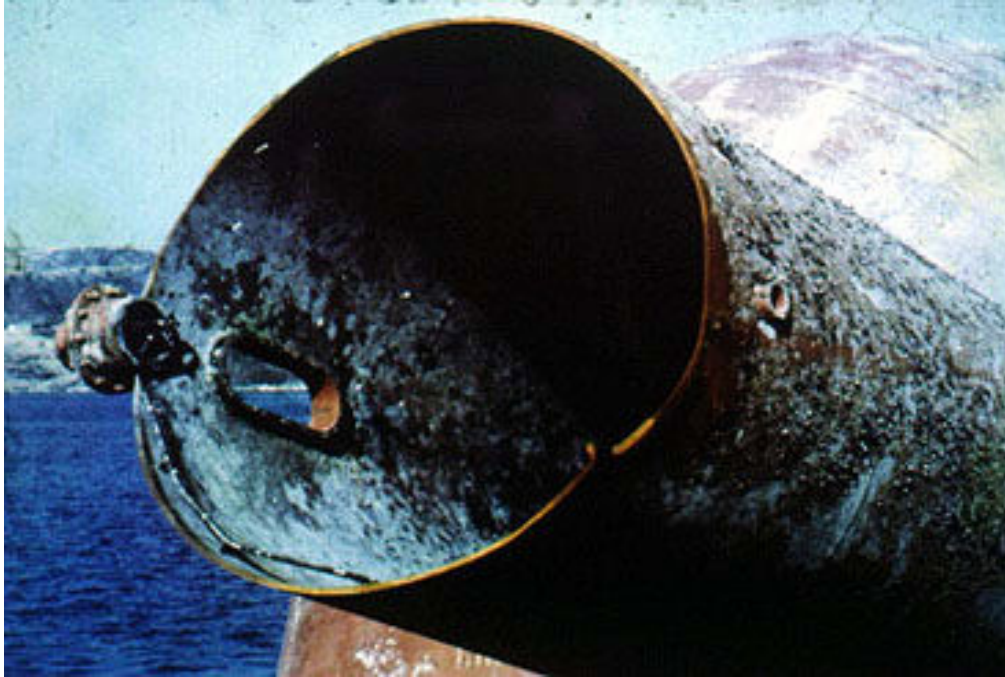
**Note :- Would the platform have collapsed if the hydrophone insert weld had been completed correctly ? the answer is a resounding ---NO ! The performance of the drainhole is testament to that, again see Figure 7.**

**Answer :** There is no evidence of an explosion anywhere on the support structure of the rig, neither in the brace D6 hydrophone area or anywhere else, i.e. no severe plastic deformation of component parts and no fracture surface indications to support this conjecture. Therefore, even if there was an explosion it must have been and was far enough away from the brace D6 to have no effect on crack formation and movement in the brace. --- Note : Carbon steel is incapable of spontaneously exploding by any mechanism that one could devise, the thought is preposterous. If there was an explosion it would likely be ‘rig topside’ which is far away from the brace D6 and could not directly affect brace D6 performance. Proof of this conclusion is that there are no signs of plastic deformation of the brace tube at the fatigue cracking position, the brace has still got its original circular shape, see Figure 7.

**Figure 7 :** The fatigue crack had propagated around the complete circumference of brace D6 from the defective origin of the hydrophone welded joint but no cracking to be observed emanating from the drainhole which is the same type of joint as at the hydrophone position.

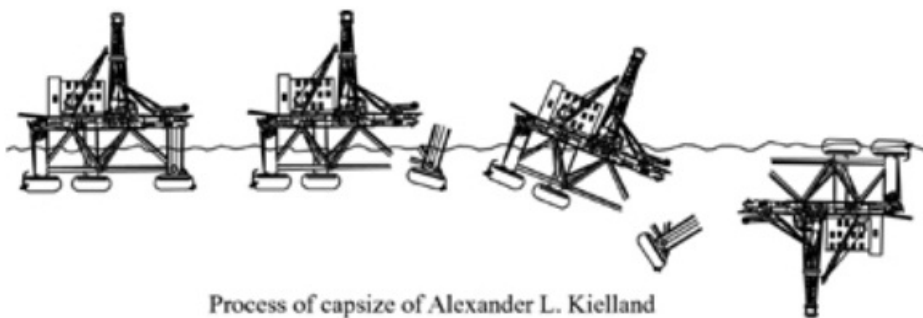
**Figure 8 :** The final series of little incidents that led to the final collapse of the Alexander L. Kielland platform/rig, from our analogy --- sadly the last of the dominoes to fall.
